**BUZZARDS BAY
RAILROAD LIFT BRIDGE
OVER CAPE COD CANAL**

INSPECTION AND CONDITION REPORT

OCTOBER, 1984

MODJESKI AND MASTERS

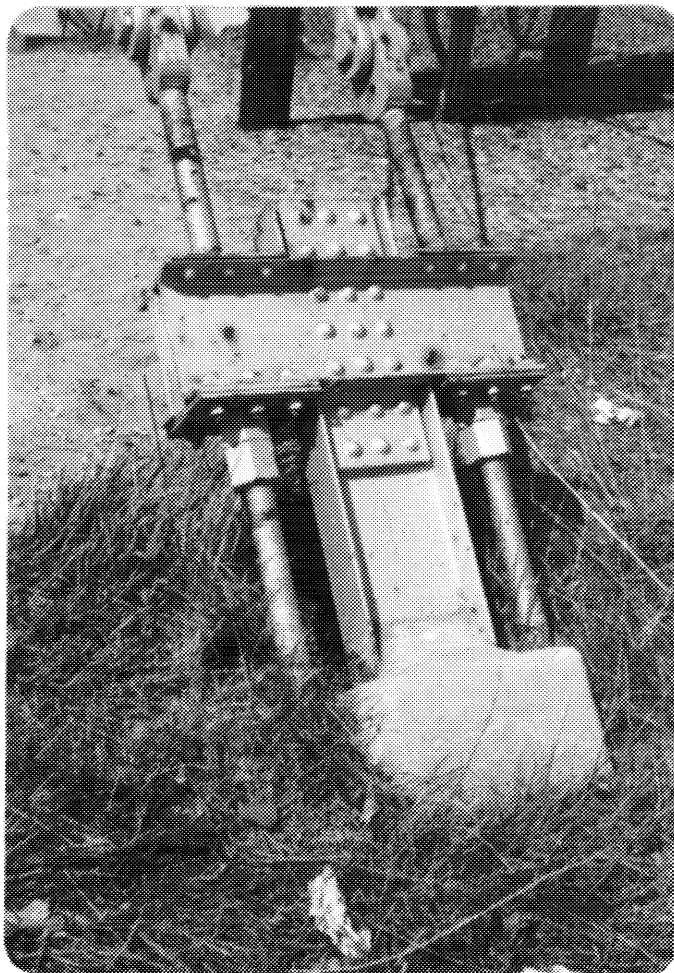
The visible elements of the anchorage metalwork are structurally sound. Surface corrosion exists on the metalwork of all four units (see Photograph I-2). Pitting, a maximum 1/16 to 3/32 inch deep, was noted in the webs of the longitudinal support beams of the north anchorages adjacent to the concrete embedment. Two 3/4 inch bolts, with beveled washers, are missing in the bottom flange of the lower transverse channel of the northeast anchorage and one other bolt is loose. A similar bolt and washer is missing at the southeast anchorage unit. Photographs II-28, 29 and 30 illustrate the other backstay anchorage units.

Photograph I-2 - Southwest backstay anchorage metalwork. Note typical corrosion.

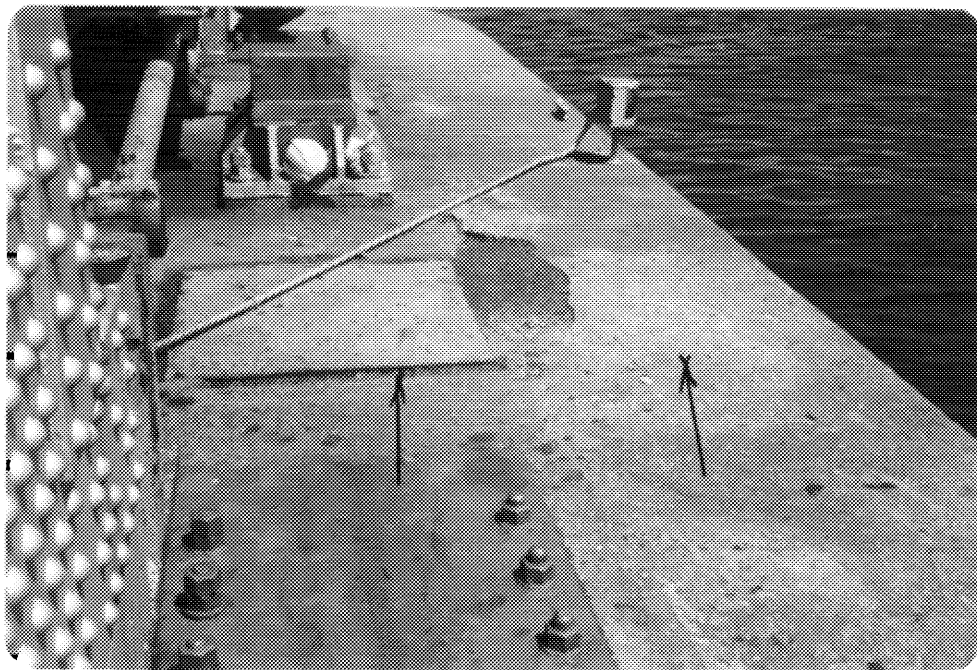
Photograph I-3 - View of spalled and unsound areas on Pier C near west jacking plate.

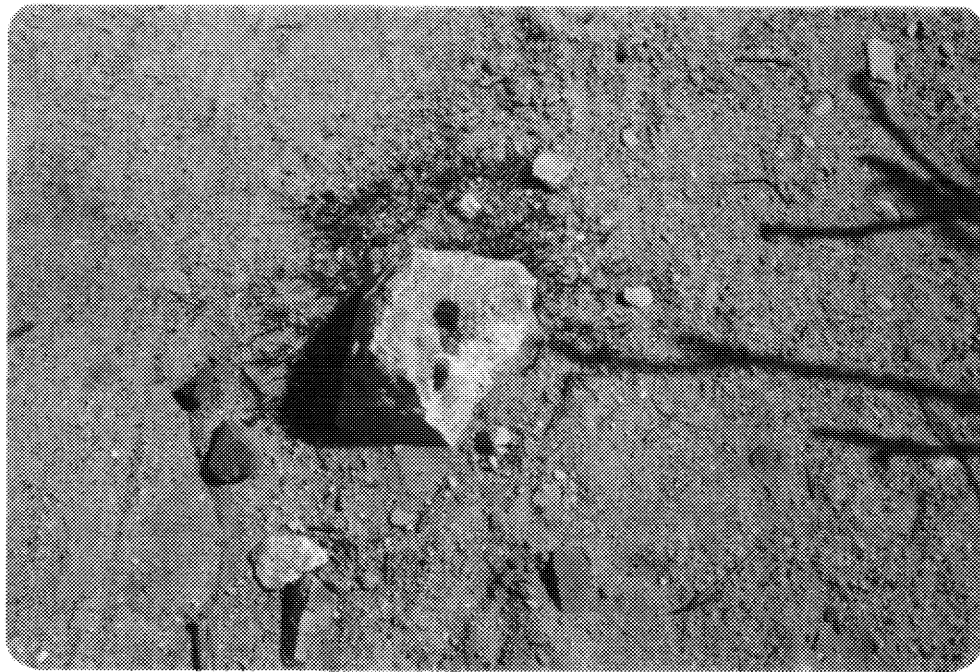
The brass plate in the southeast horizontal control monument (AE) was found missing and the top of the monument spalled (see Photograph I-4). The monument appears to be in the direct line of a bicycle and motor cycle path from an adjacent road along the Canal (refer to Photograph II-23).

Photograph I-4 - Bronze plate is missing and the concrete is spalled on horizontal control Monument AE. Note adjacent bike tracks.

11. Establish new horizontal control Monuments AE and AW on the south side of the channel.
12. Continue periodic alignment, elevation and sounding checks for the bridge substructure.

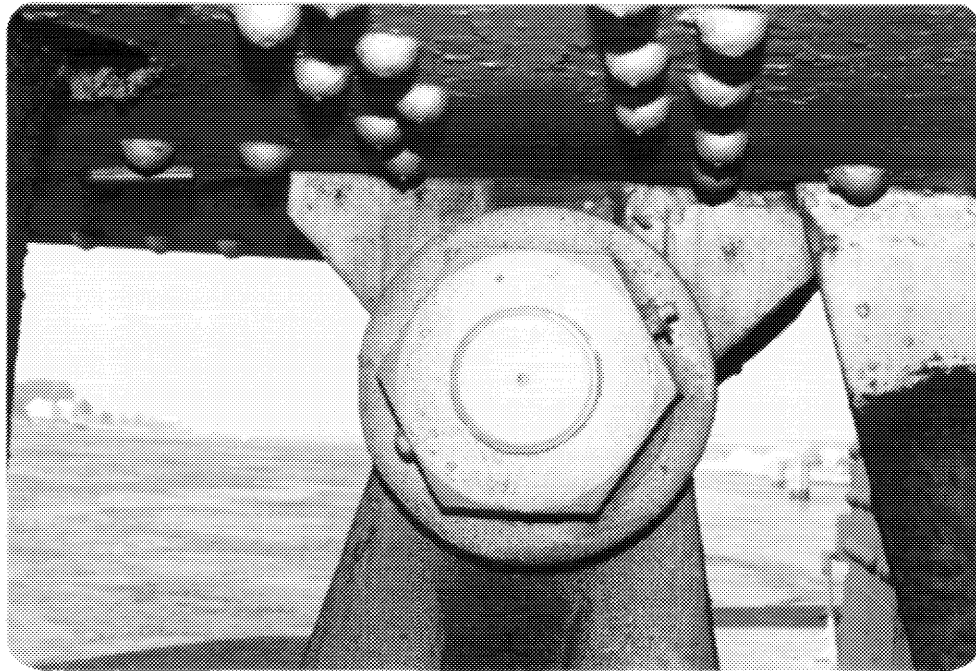
A small gap and rust stains, indicating minor relative movement, was observed between the expansion bearing upper shoes and the truss horizontal connection plates on the inboard end of both devices. A scraper blade can be inserted in the gap at the west bearing (see Photograph I-5). This condition may be caused by elongated connection bolts.

Photograph I-5 - Note rust stains and gap between west expansion bearing upper shoe and horizontal connection plate.

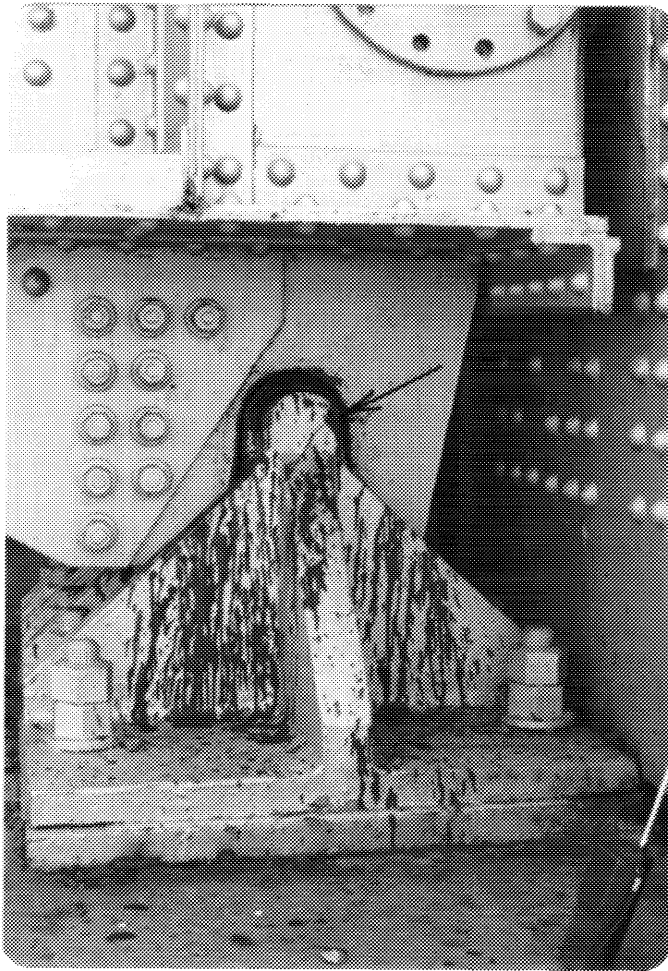
During and after seating of the lift span, contact exists on the south portion of the circular wear plates for the west fixed bearing upper and lower shoes. A 1/8 inch gap exists on the top and the north side between the wear plates of the west shoes (see Photograph I-6). Normal wear exists at the point of contact. Contact between the circular surfaces of the upper and lower shoes at the east fixed bearing is at the crown. Moisture and debris is being trapped in the pockets of the fixed bearing lower shoes (see Photograph II-56).

Photograph I-6 - Arrow indicates point of contact between shoes at west fixed bearing.

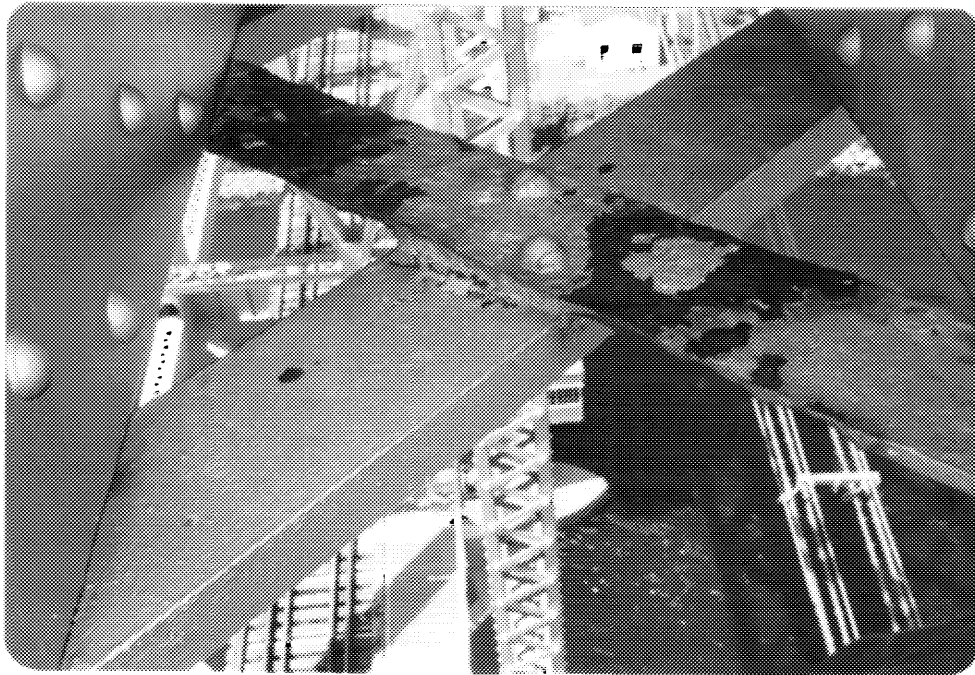
channel and bar sections. Major section loss has occurred in the bar sections, generally between Panel Points 4 and 6 and between Panel Points 4' and 6' on both trusses (see Photographs I-7 and II-61 and 64). The channels have packed rust and section loss at their connections to the chords.

Photograph I-7 - Deteriorated lacing bar in east top chord between Panel Points 5' and 6'.

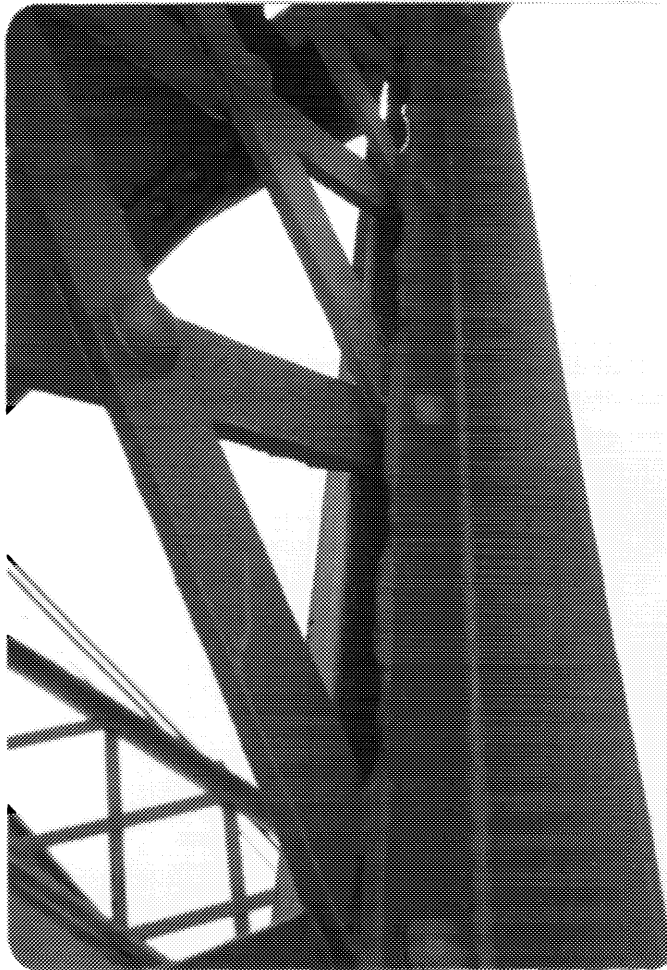
Corrosion over an extended period of time has developed pitting and general section loss on the bracing members. The existing loss on the top lateral bracing is generally confined to the lacing bars and is not considered significant. Section loss in the sway frame lacing and several angle sections is considered more serious and may become detrimental to the functioning of the members (see Photograph I-8). Packed rust and minor section loss is evident on members at the edges of connection plates.

Photograph I-8 -
Section loss in sway
bracing angle at
Panel Point 2'.

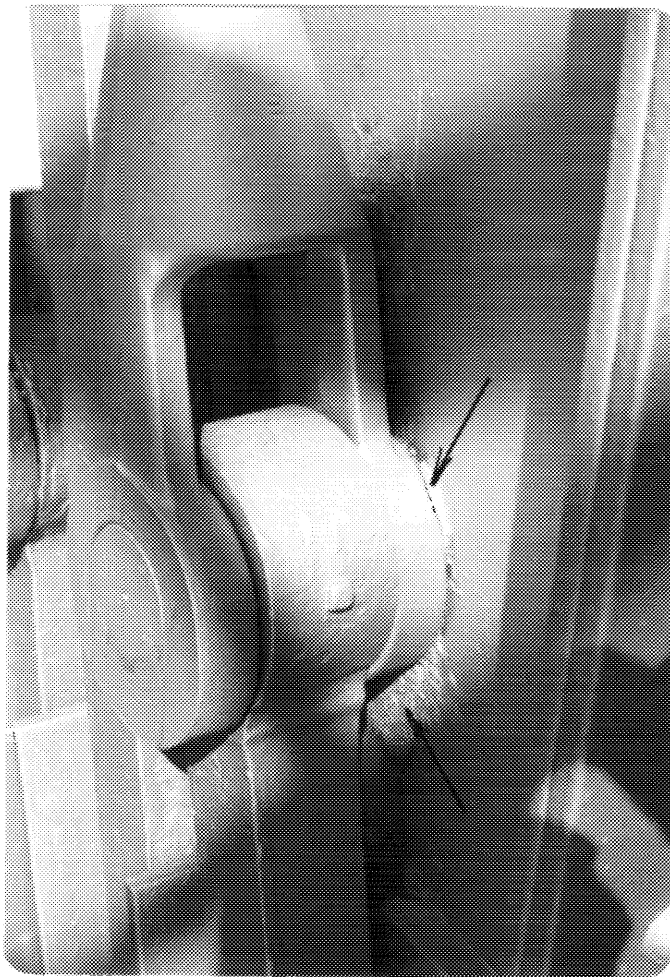
The bottom flanges of the lifting girders have a heavy build-up of paint and trapped debris, which is retaining moisture and accelerating corrosion. The girder web areas behind the counterweight rope take-up bars and sockets is not accessible for cleaning and painting. Corrosion residue and section loss, up to 1/8 inch in depth, was visible in the lifting girder webs at these locations (see Photograph I-9). Separation of paint cover was noted on other areas of the girder webs.

Photograph I-9 -
Corrosion and section
loss is typical in
the lifting girder
webs at the counter-
weight rope
connections.

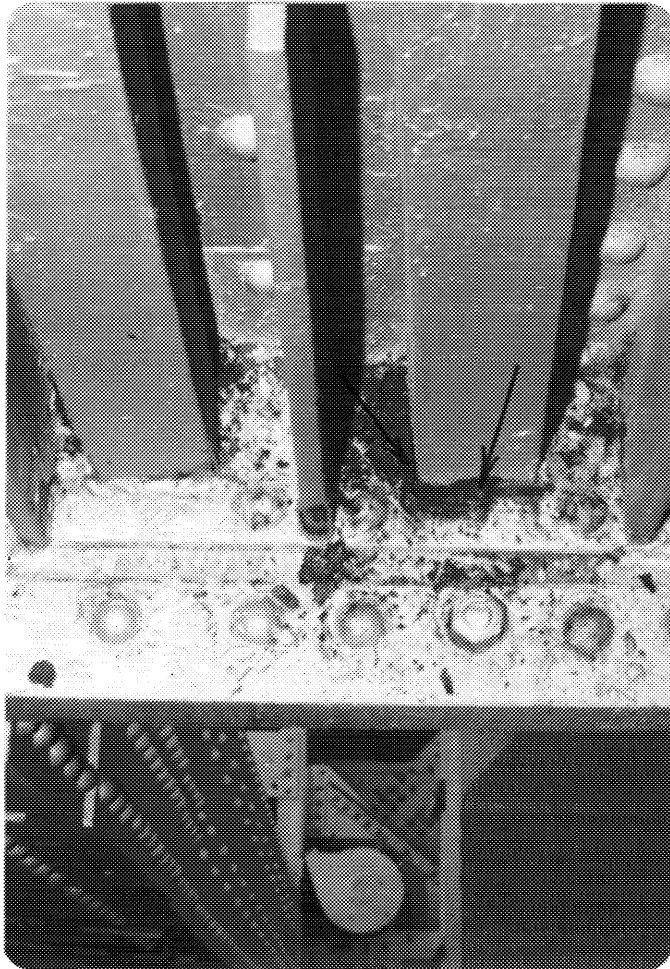
A minor amount of section loss exists on the counterweight rope take-up bars at the lifting girder bottom flange. Moisture is being retained in the open gaps between the bar and the flange (see Photograph I-10).

Photograph I-10 -
Typical corrosion and
gaps between take-up
bars and lifting
girder bottom flange.

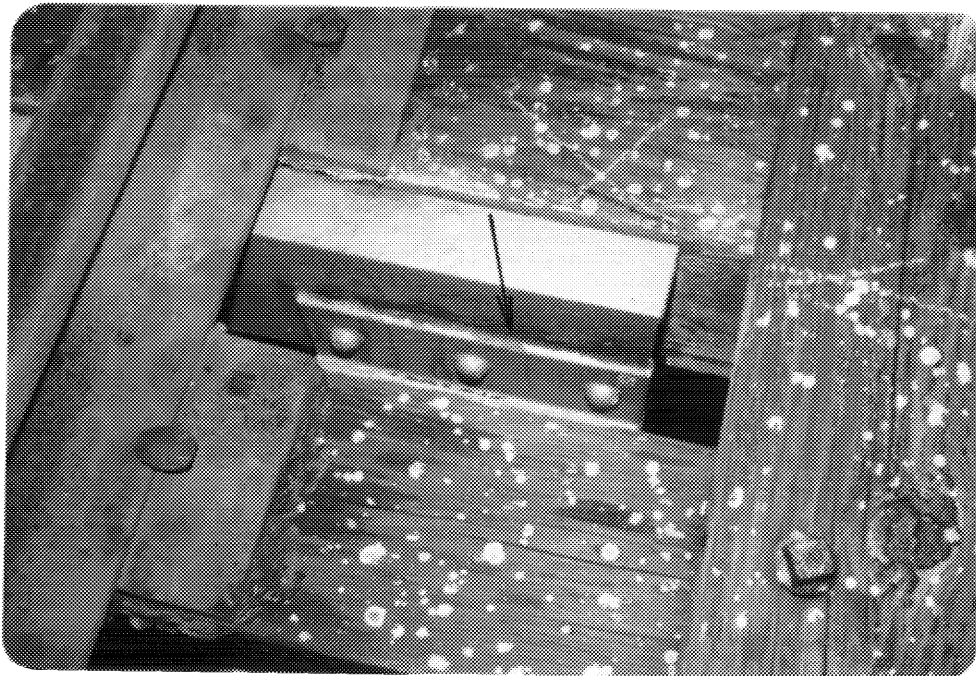
The webs of many walkway transverse support channels are corroded with up to 1/8 inch of section loss at the top of the connection angles on the stringer top flanges (see Photograph I-11). In addition, the heads of the rivets through the channel bottom flanges at the stringers have loss of section. At each channel a timber tie abuts the open side of the member, preventing access for cleaning and painting. The open sides of the channel should be thoroughly cleaned and painted and deteriorated rivets replaced when ties are replaced. Additional rivets on the back side of the channels pass through the connection angles mentioned above to add redundancy.

Photograph I-11 - Typical area of corrosion and section loss in walkway support channels.

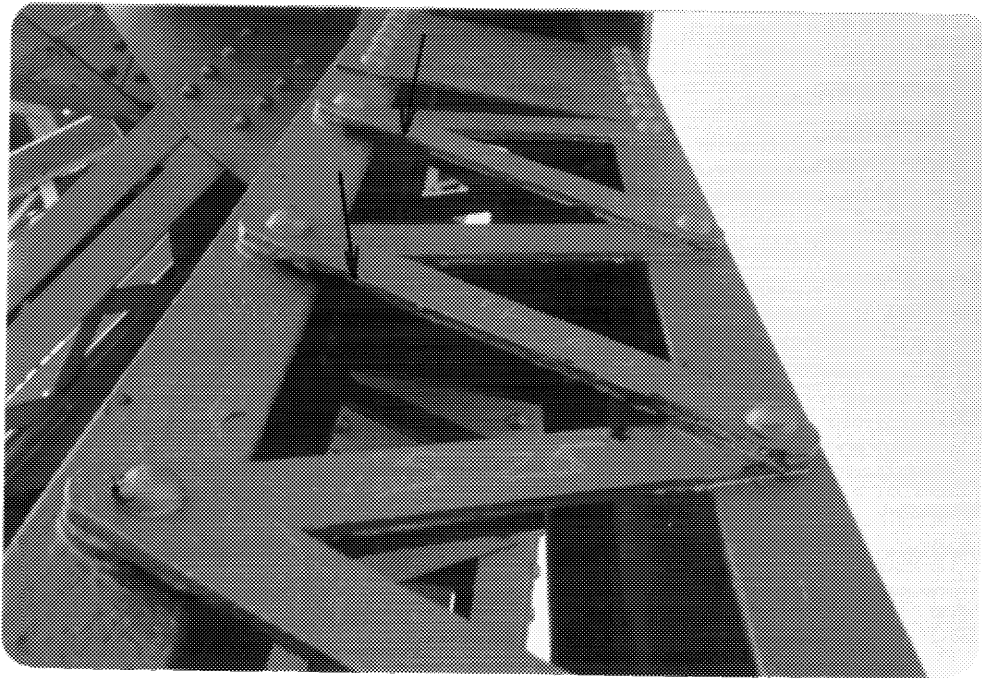
Several minor deficiencies were noted in the trusses. Lacing bars, with a minimum of 25 to 30 percent section loss exist at locations, with the majority in the verticals and diagonals (see Photograph I-12). Table 2-2, attached, is a listing of lacing bars with a minimum of 25 to 30 percent section loss.

Photograph I-12 - View of deteriorated lacing bars on west truss Member U2-G.

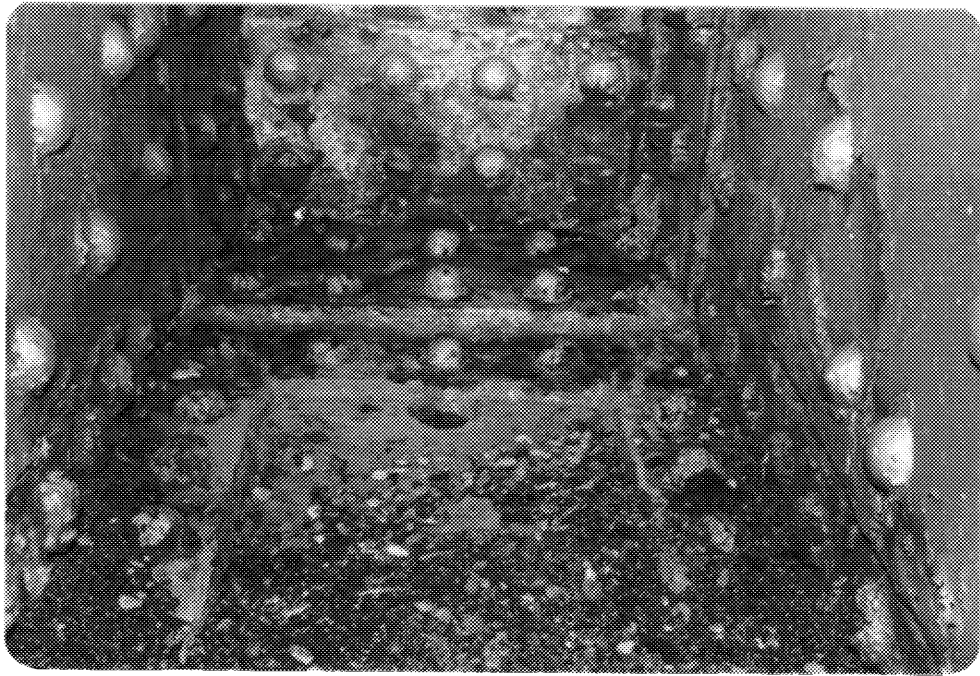
Corrosion is active to some degree on all members, but is most apparent at the bottom chord joints (see Photograph I-13). Pigeon waste and other debris has accumulated in the top and bottom chord joints.

Photograph I-13 - Typical corrosion in truss lower chord joints.

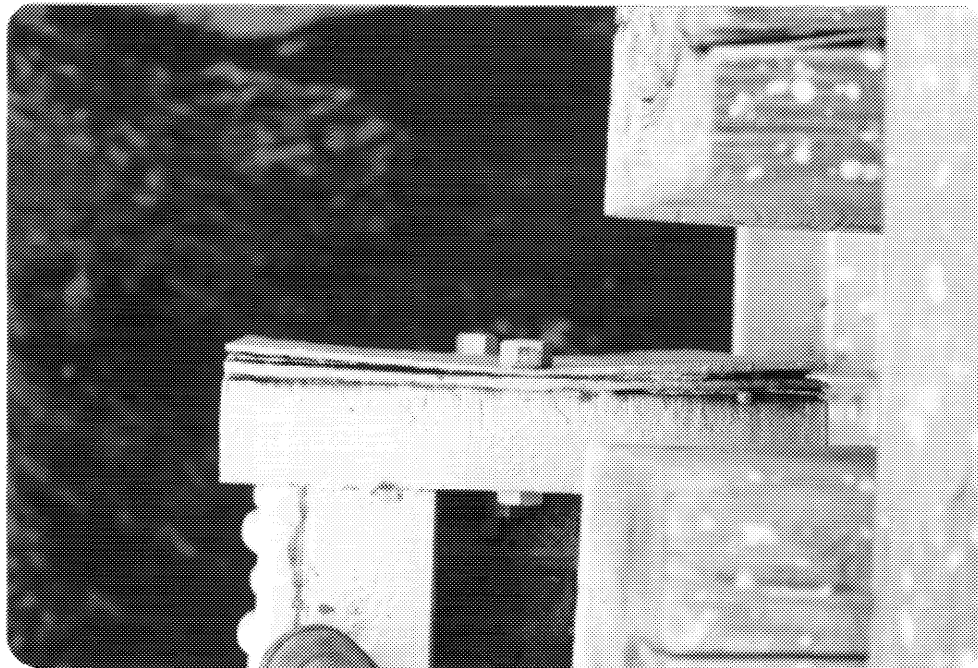
Two jacking struts are provided for placement between the lift span end floorbeam and lifting girder when the counterweight ropes are replaced. One strut is stored in the north span and one in the south span along the west stringer between Panel Points 1 and 2. The repairs recommended for the struts in the 1971 Inspection Report were completed. Drain holes were provided in the web; however, corrosion of the strut metalwork is continuing. Packed rust has formed between the shim plates on the north end, causing section loss and displacement of the plates (see Photograph I-14).

Photograph I-14 - Displaced shim plates and packed rust at lower end of north span jacking strut.

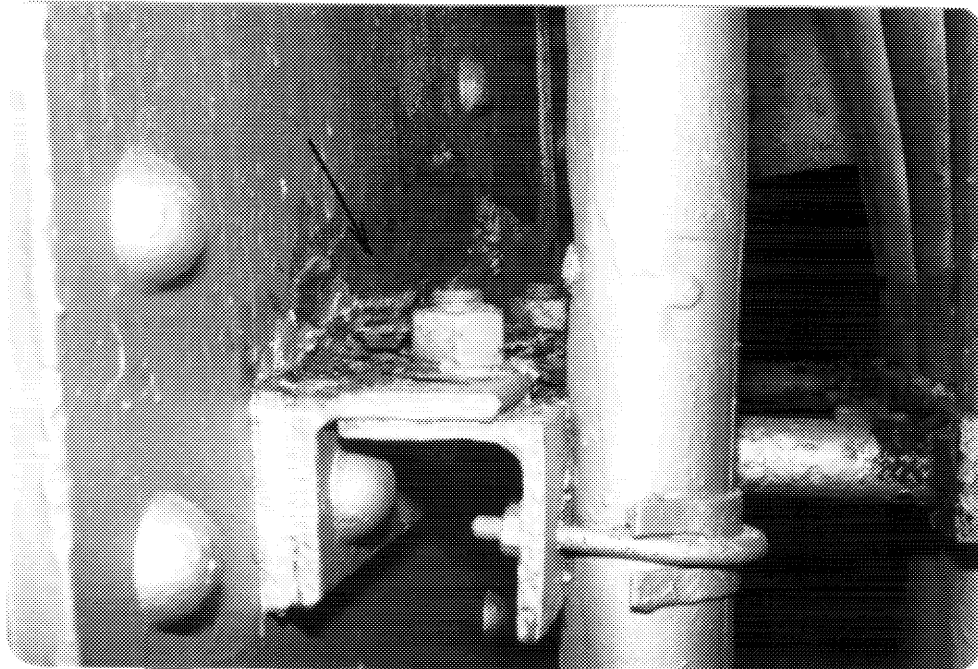
Corrosion and section loss are a concern on the outboard side of the interior web plates of the rear columns directly above the electrical conduit support angles (see Photographs I-15 and II-137). The web section loss is presently 1/16 to 1/4 inch in depth along the top of the angles. The area is not easily accessible and was not thoroughly cleaned during the most recent painting contract. The support angles should be removed to aid in thoroughly cleaning and painting the web plates. Support angles not presently being utilized, should not be reattached.

Photograph I-15 - Corrosion and section loss on interior web plate at bracket near top of east rear column.

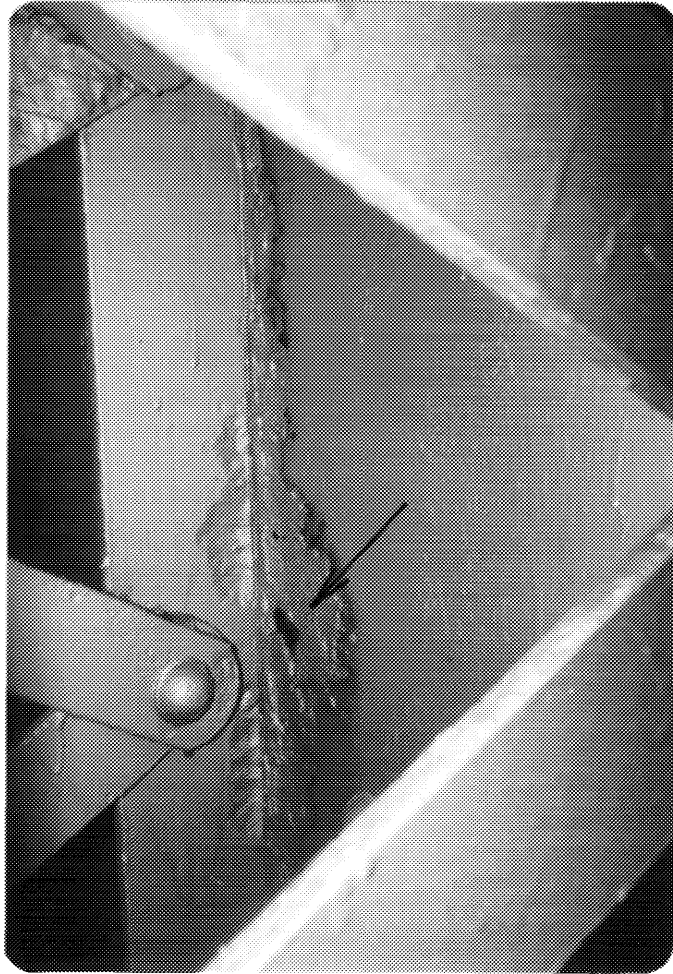
Section loss also exists on the inboard side of the web plates of the rear columns adjacent to the vertical connection angles for the center set of lacing (see Photograph I-16). The present depth of loss is 1/8 to 3/16 inches. This area will require special cleaning and painting.

Photograph I-16 -
Corrosion and section
loss in rear column
web plate adjacent
center lacing connec-
tion angle.

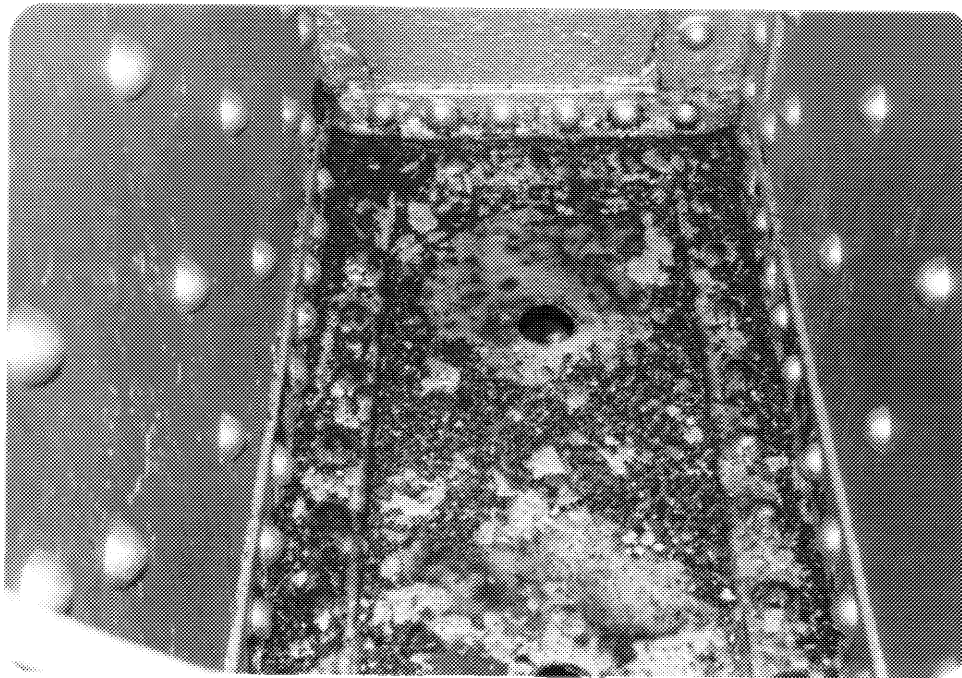
Excessive deterioration exists in several lacing bars of the bracing members. Those with section loss in the range of 25 to 30 percent and over are listed in Table 2-2. The front tower columns are perforated on the rear face and a horizontal diaphragm plate is located in the column, just below each opening. Extensive corrosion exists on the diaphragm plates, connection angles and rivets. Typically, the rivets are "blossoming" with an estimated 15 to 20 percent section loss and the angles and plates are generally laminated (see Photograph I-17 and II-141). Metalwork corrosion in the west front column is more advanced, with some rivet heads having more than 50 percent loss of section.

Photograph I-17 - Typical corrosion on diaphragm plates, angles and rivets. Rivets have an estimated 15-20 percent loss of section.

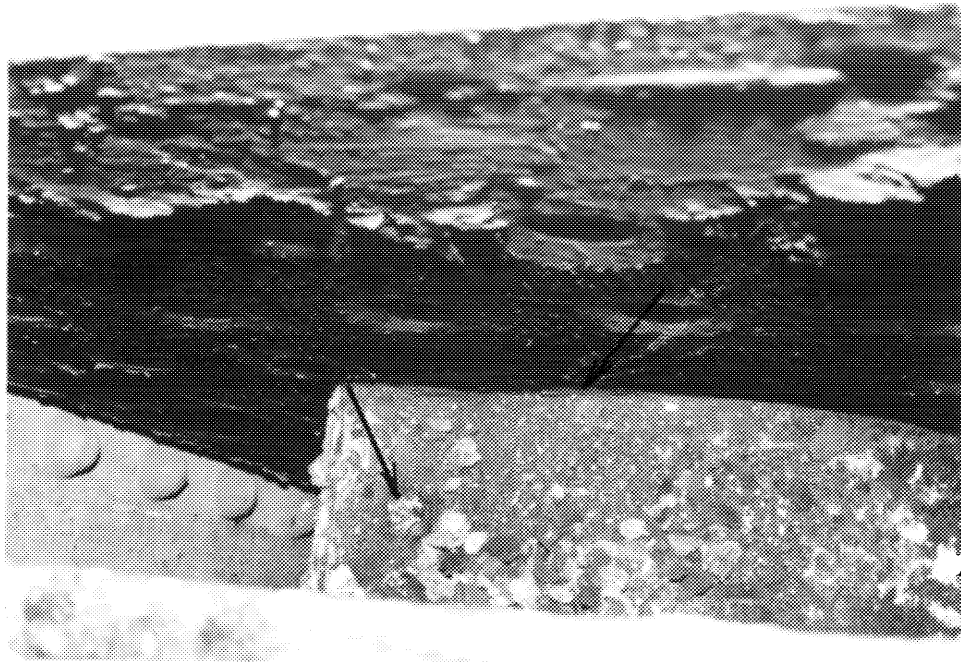
The interior sides of the counterweight hangers and adjacent support metalwork and the pin collars have not been recently painted. Corrosion has caused a maximum of 1/8 inch depth of pitting in the hangers and adjacent support plates at the pin collars. The heads of fasteners for the pin collars are severely deteriorated (see Photograph I-18). The pin collars should be removed and the metalwork sandblast cleaned and painted.

Photograph I-18 - Typical corrosion and minor section loss on pin collars and fasteners and interior surfaces of counterweight hanger plates and support metalwork.

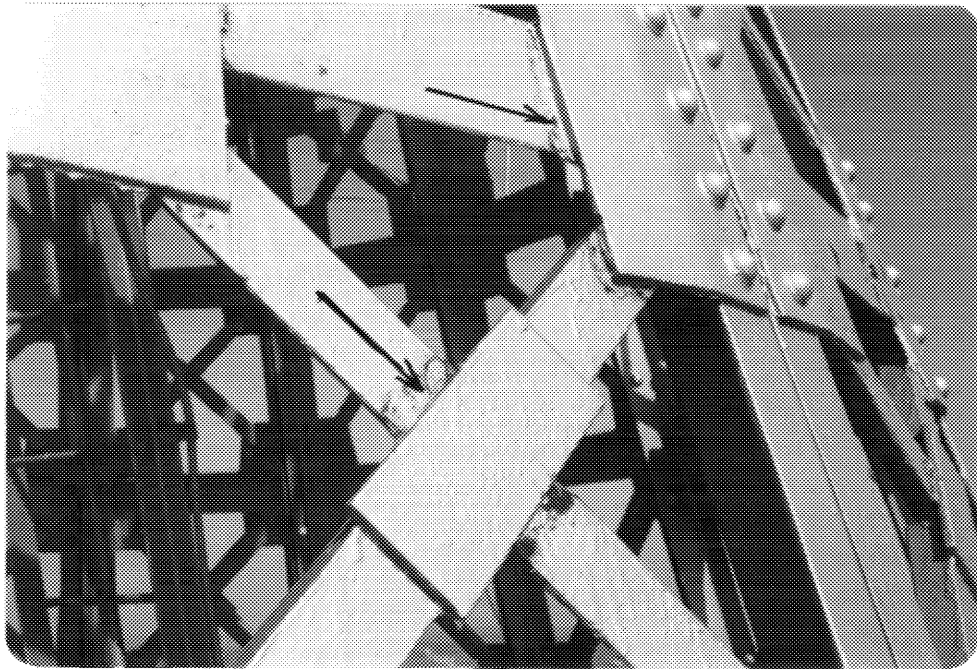
The decorative spire atop the machinery house enclosure consists of a welded lattice of angles. Packed rust and moderate section loss exist on these members adjacent to the connection plates (see Photographs I-19 and I-20). Many of the welds are broken, usually at the horizontal angle connections. A listing of broken weld locations is provided on Figure 2-7.

Photograph I-19 - Typical corrosion and minor section loss on north tower spire metalwork.

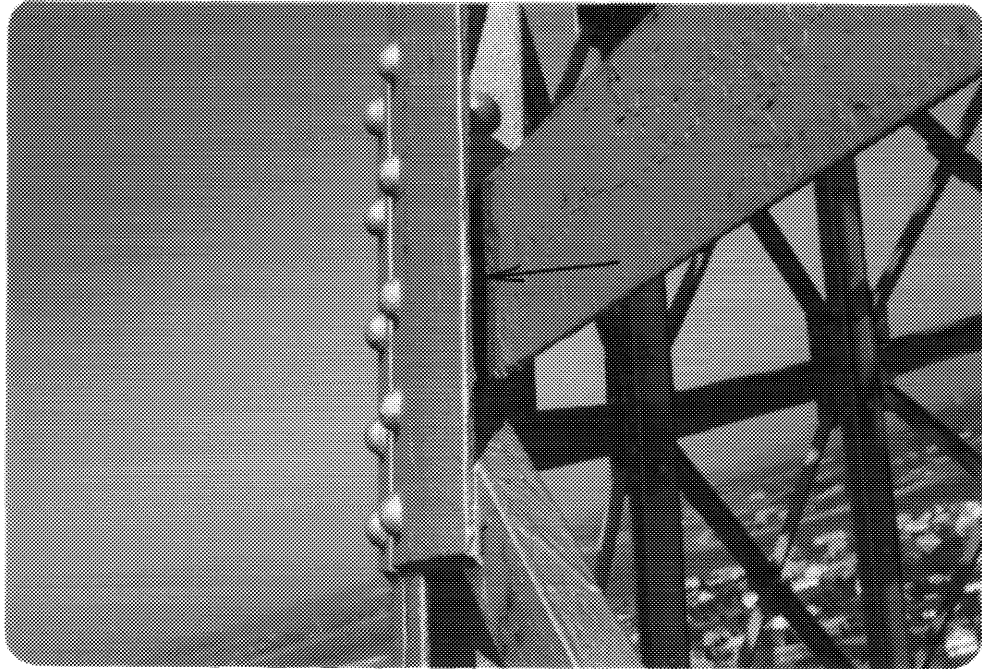
Photograph I-20 - Separated horizontal brace of north spire.

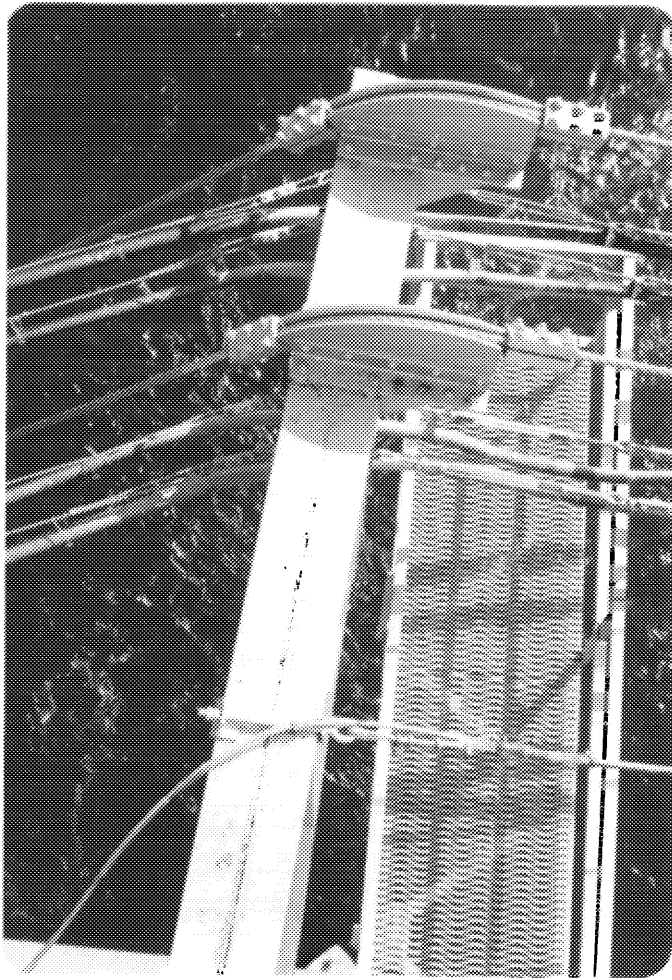
The catenary brackets supporting the messenger cables on the east and west sides of the tower are pivoted toward the channel and the outboard ends rotated toward the channel (see Photograph I-21). The bracket rotation has apparently developed since the new messenger cables were installed in 1976-77, as no deformation was reported in the 1971 Inspection Report. Each bracket was plumbed at three locations and the amount of offset between the top and bottom flanges and the degree of rotation is tabulated on Figure 2-8. No structural cracks were observed in the bracket metalwork. The brackets should be analyzed to determine if remedial measures are required.

Photograph I-21 - Plan view of northeast catenary bracket.

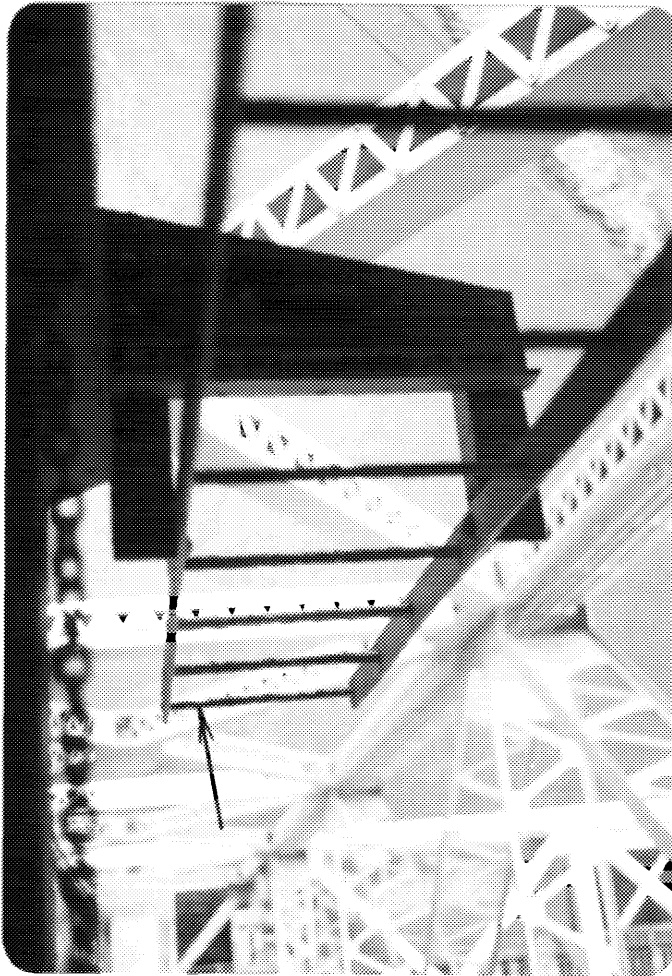
- a) The railing post at the east end of walkway support channel 17 is severely deteriorated above the lower connection.
- b) The lower and mid-height horizontal railing pipes above support channel 19 and between the span longitudinal railing and the stairs are cracked at mid-length. A similar crack exists in the lower pipe above support channel 17.
- c) Two fasteners for the connection of the outboard railing post to the stairway stringer at support channel 26 are deteriorated.
- d) The rungs on the lower end of the short ladder used for access to the counterweight at the top of the tower are severely deteriorated (see Photograph I-22).

Photograph I-22 -
Section loss in rungs
of access ladder to
counterweight.

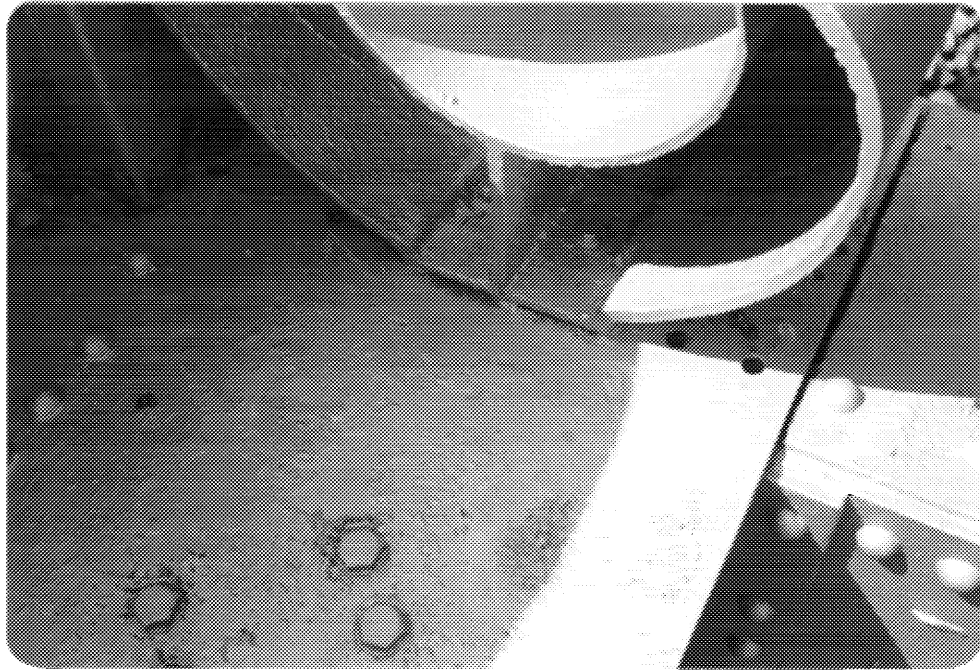
Five fasteners are missing in the upper lateral connection plate on the top chord at Panel Point 4, west truss (see Photograph I-23). Three fasteners are missing in the connection of a support bracket angle for the ornamental ironwork on the portal strut near bridge centerline at Panel Point 4. The west decorative ball at Panel Point 4 is dented (see Photographs II-118 and 119).

Photograph I-23 - Missing fasteners at Panel Point 4, west top truss.

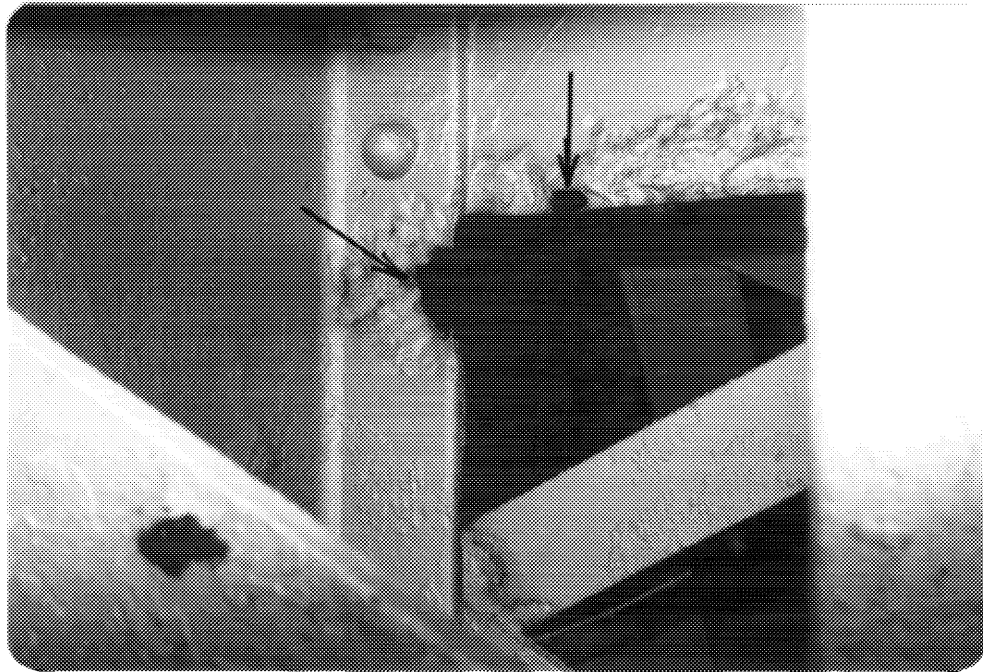
Section loss at the upper end of the east bracing member P-C1, has caused approximately 75 percent loss of section in the lower flange of the inboard channel (see Photograph I-24). The photograph also indicates section loss on the edge of the adjacent stay plate.

Photograph I-24 - Section loss on channel and stay plate of east bracing member P-C1.

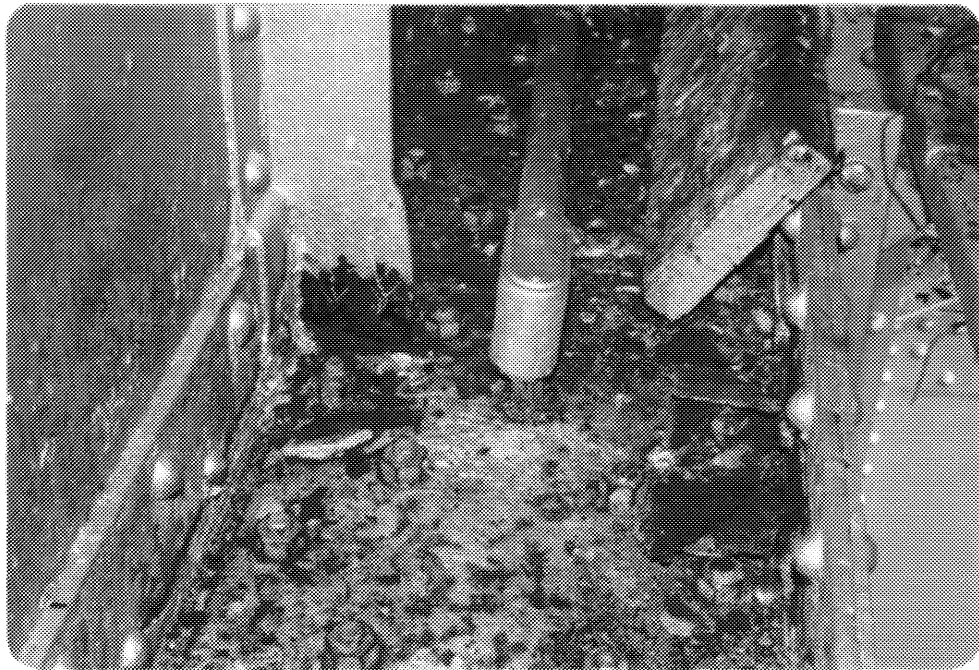
- a) Bird waste, grease, paint accumulations and debris on the sheave girder flanges and horizontal connections. Similar accumulations exist in the small gratings adjacent the counterweight ropes.
- b) Corrosion and pitting on the interior surfaces of the counterweight hanger metalwork.
- c) Corrosion, section loss and warping of the 18" x 3/8" horizontal plates attached to the outboard lower flanges of sheave girders G1-E and G1-W.
- d) Extensive section loss in the lower ends of the outstanding legs of the web stiffener angles on the outboard side of sheave girders G1-E and G1-W (see Photograph I-25).

Photograph I-25 - Section loss in horizontal plate, fastener nuts and lower ends of stiffeners on outboard side of Girder G1-E.

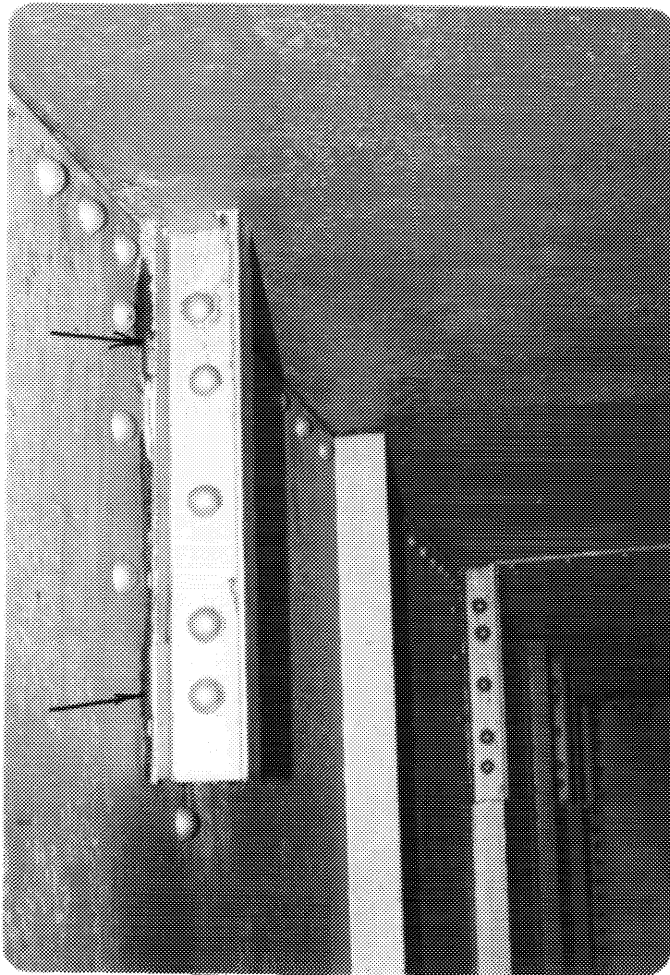
- e) Corrosion with separated paint on the exterior surfaces of the machinery house and fascia girders. Corrosion and moderate section loss on the backside of the fascia girders adjacent to the balcony railing posts (see Photograph I-26).

Photograph I-26 -
Arrows indicate typical corrosion along railing posts at fascia girders.

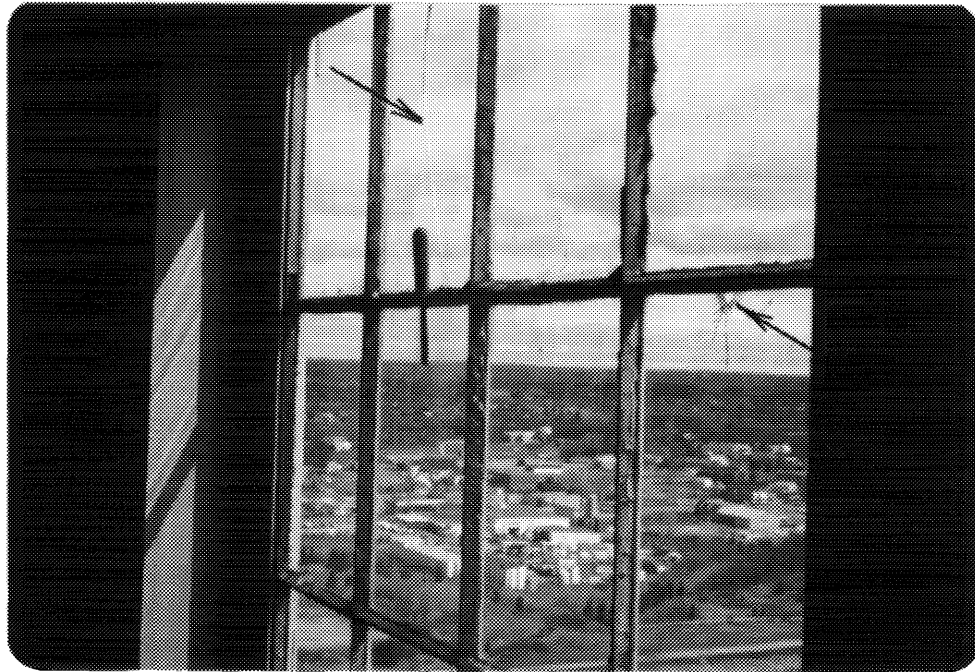
- a) Fourteen fasteners are deteriorated on the north face of the sheave room enclosure (see Photograph II-170).
- b) The number of broken window panes and the amount of deteriorated glazing for the machinery house windows is greater than at the north tower. In addition, lower areas of the window frames have nearly 100 percent section loss (see Photograph I-27).

Photograph I-27 - Section loss in window frames and broken panes are typical in south tower machinery house.

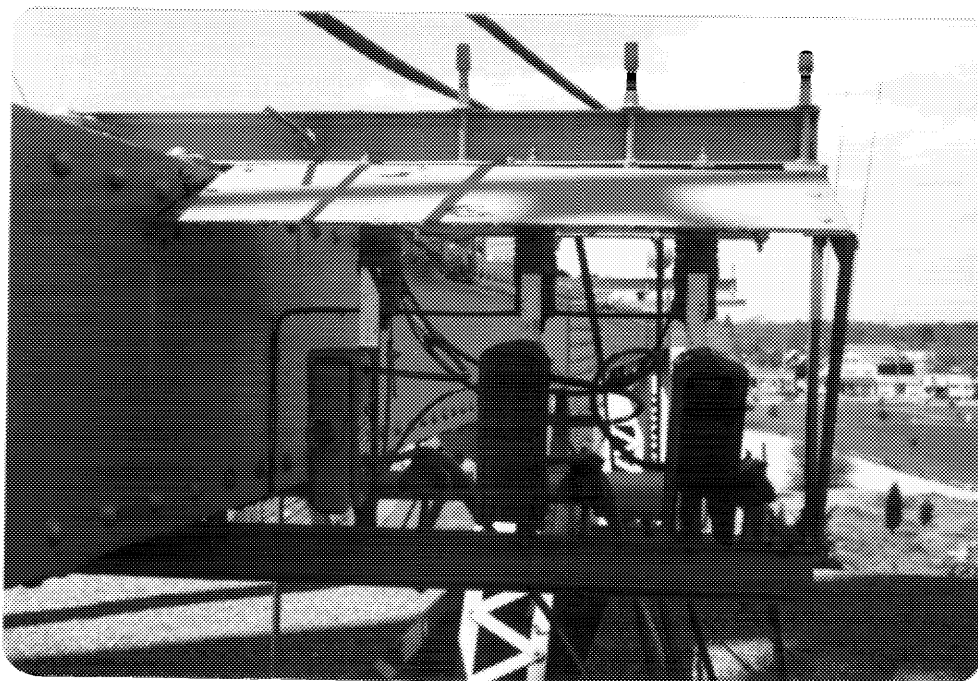
Photograph I-28 - High voltage fuse assemblies on control house roof. Note broken unit, far right.

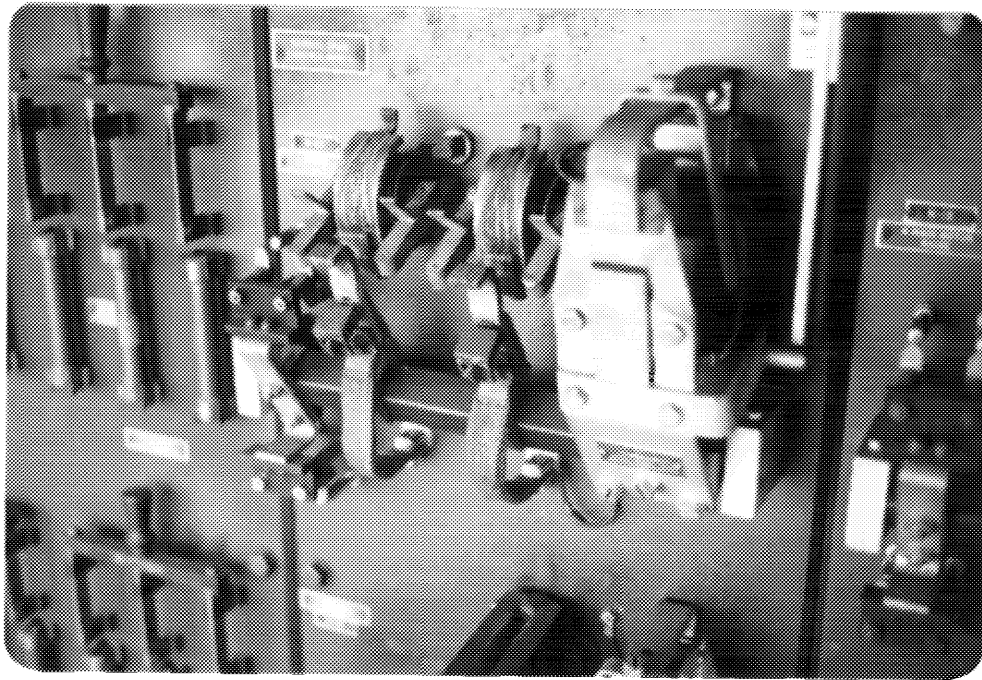
Photograph I-29 - Selsyn excitation contactor with arc chutes removed to show pitting and scorching of the contacts and arcing horns.

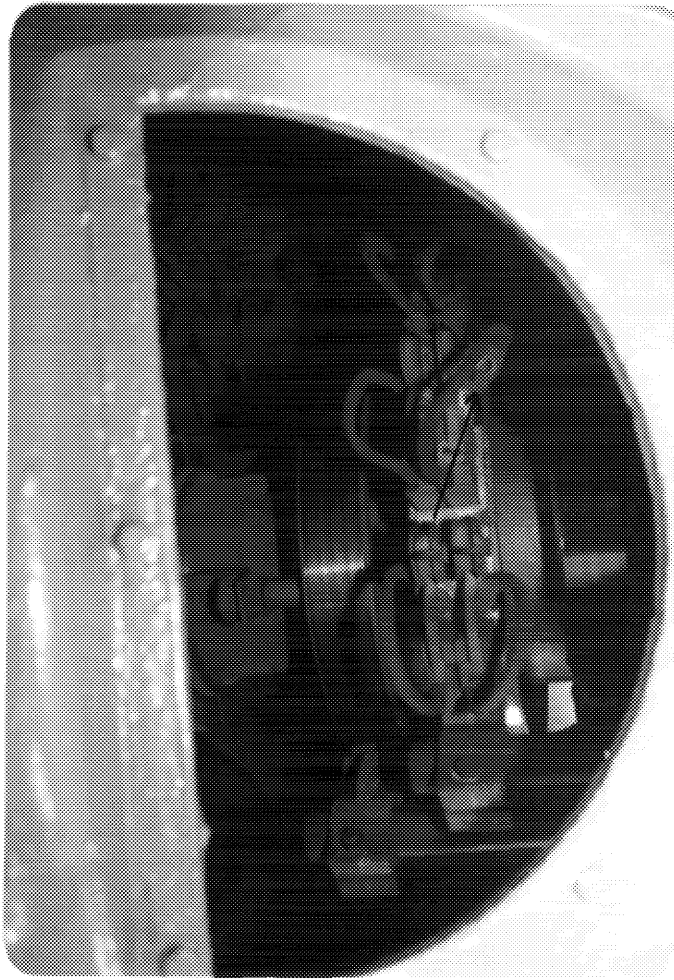
Photograph I-30 - Loose wire terminal on drive motor brush holder assembly, resulting from sheared terminal screw.
